## **APPLICATION NOTE: 203**

**A**pplication: Gear Inspection - Presence/Absence of Timing Index Hole and Painted Indicator Marks with respect to Keyway Slot.

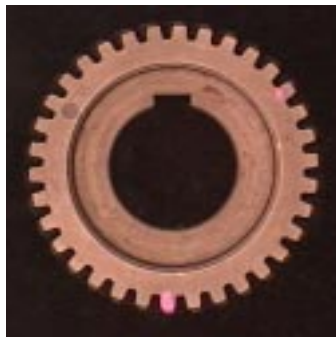
CABI at 3200K

Since the surfaces are basically flat and specular, the first choice would be a CABI based device which provides coaxial brightfield illumination structure. The results of this approach can be seen in the first image. The uniformity is excellent but the contrast of the index hole is poor. This is a direct result of the coaxial brightfield structure. The color contrast of the pink paint dots is poor because of the high red content of the Tungsten Halogen lamp (3200K).

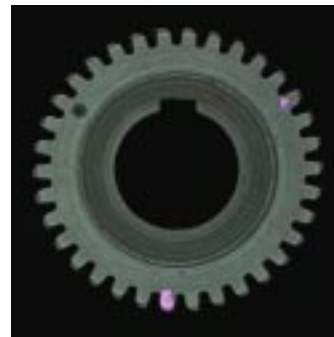
DRI at 4200K

To solve this problem, a fiberoptic DRI system was employed. The DRI provides the structure required to ensure good uniformity and create good contrast of the hole. Utilizing a 4200K color temperature lamp significantly increased the contrast ratio of the paint spots. Because of the strong nature of the illumination solution, this application could be solved by a monochrome vision system. However, a color vision system was chosen to facilitate the potential changes in paint color and hue in the future.
