APPLICATION NOTE: 212

Application: Inspection of injection molded parts

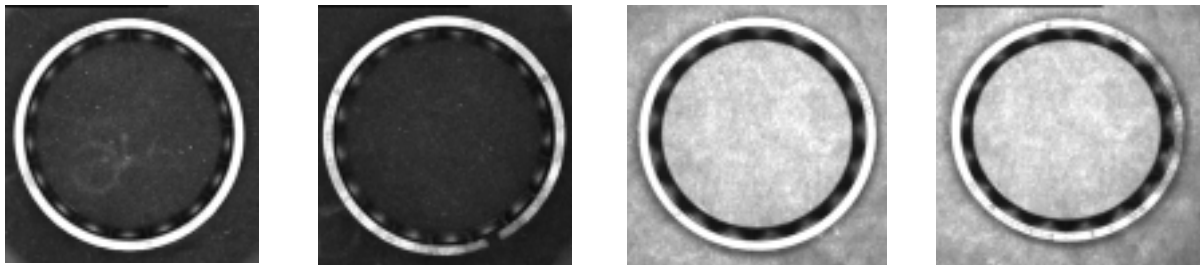
To solve this problem, a simple ringlight is not sufficient. The first two images show that defects can be found in the top surface of the part, but low contrast fails to show other defects.

The structure of the light must be low angle, highly uniform, and symmetric about the camera axis. Our DRI solution is designed specifically for these types of applications. The DRI solution ensures the proper structure for reliable surface defect detection, independent of the defect orientation. The resultant three level images show that all defects can be identified. The DRI lighting system is powered by a 3900 Smart-Lite which provides the output stability necessary to ensure that the algorithm remains robust and reliable. Together these lighting performance factors give the system a robust front end that guarantees long term system reliability in a production environment.
